**EXAMINING THE EFFECTS OF THE GARRISON LAKE FOREST FIRE OF  
2021 ON THE SURFACE WATER QUALITY IN BELL CREEK'S WATERSHED**

A project report submitted in partial fulfillment of the requirements for the  
degree of

BACHELOR OF TECHNOLOGY IN ENVIRONMENTAL ENGINEERING

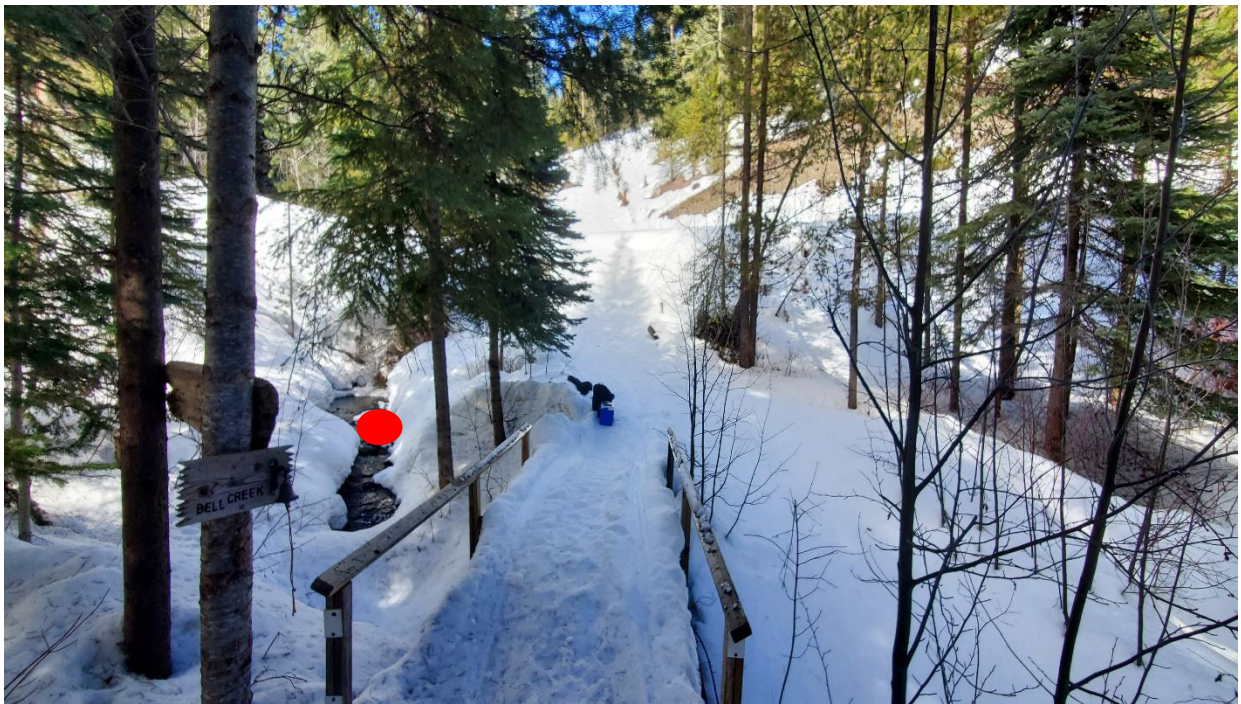
**Figure 4:** *Picture of Bell Creek Sampling Location*

*Note.* The sampling location in Bell Creek is just to the left of the cooler, denoted by a red circle. The photo is taken from the south end of the bridge facing north

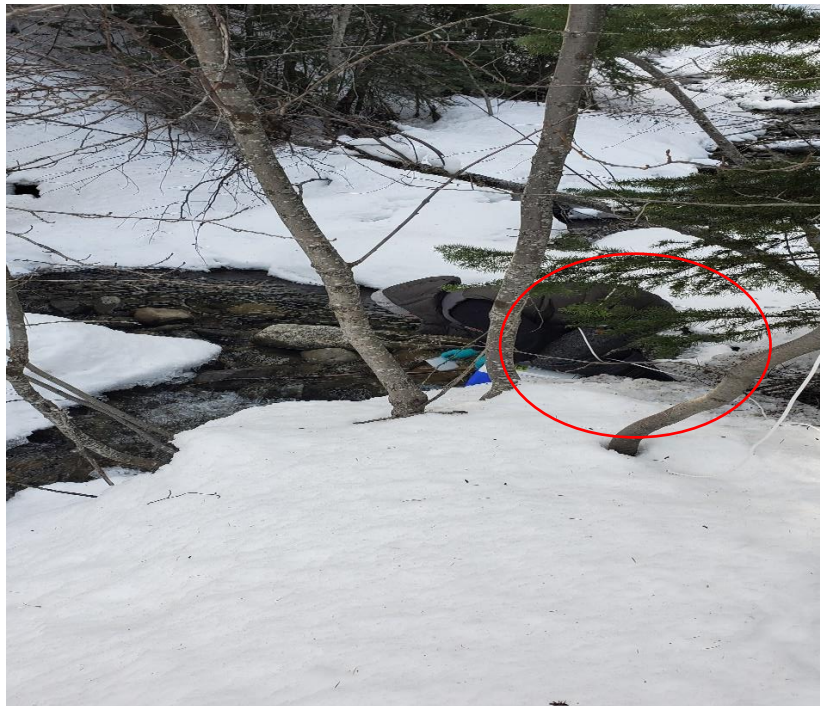
**Figure 7:** *Picture of Sampling Location at Hampton Creek*

*Note.* The picture was taken facing west, approximately 40 metres north upstream of Highway 3. The safety rope tie-off is circled in red.

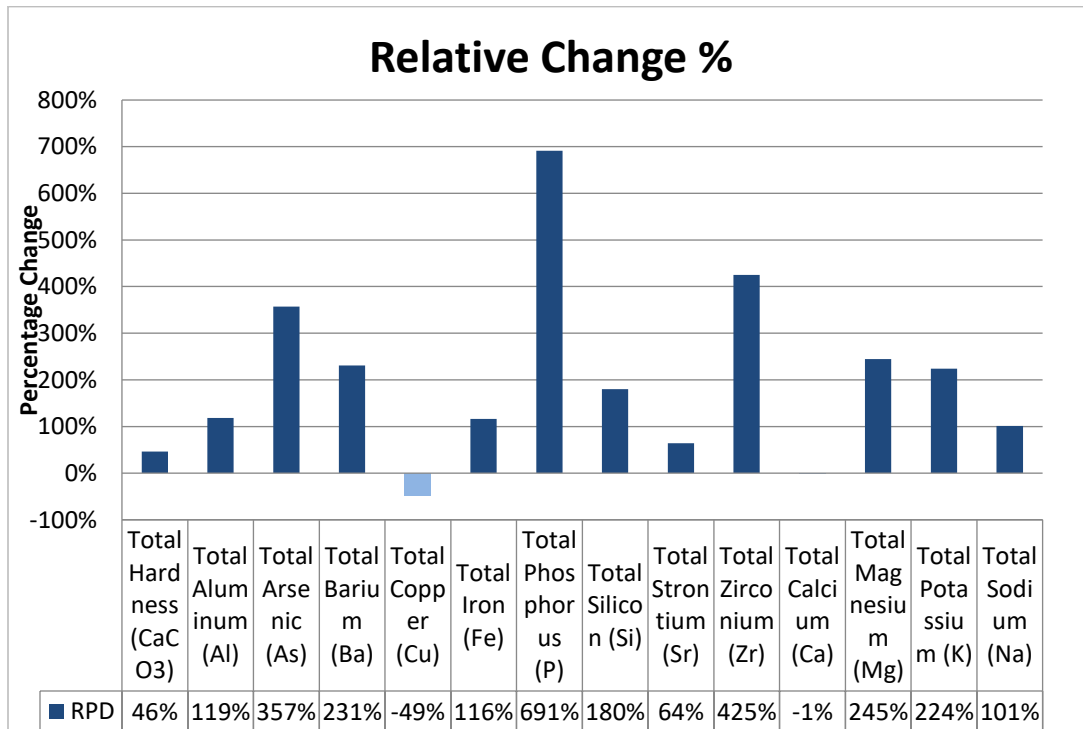
**Figure 9:** *Relative Change Percentage for Total Metals*

*Note.* Figure represents the Relative Change % of the concentrations of Bell Creek compared to the control stream (background concentration).

No metals in Bell Creek exceed the guideline values. However, zinc was measured to be over the long-term chronic guideline for freshwater aquatic life, indicating a high regional background concentration. There is a trend of higher metal concentrations in the burnt watershed of Bell Creek when compared to the unburnt control. However, these values do not exceed regulatory guidelines. There are many metals that BC does not have guidelines for, as shown in Table 3. Smith et al. (2001) reported concentrations at high values well above guidelines for Fe, Mn, As, Cr, Al, Ba, and Pb. These guidelines were not BC drinking water guidelines as the study area was in America. The results of the Bell Creek analysis do not indicate there is an issue with total metal concentrations. However, studies show the main driver of increased concentrations is high-intensity rainfall which flushes metals into the downstream water bodies (Murphy et al., 2016), which has not occurred this year as of the sampling date.
